QUINEBAUG RIVER BASIN  
SOUTHBRIDGE, MASSACHUSETTS

**NO. 5 RESERVOIR  
MA 00693**

**PHASE I INSPECTION REPORT  
NATIONAL DAM INSPECTION PROGRAM**

JUNE 1981

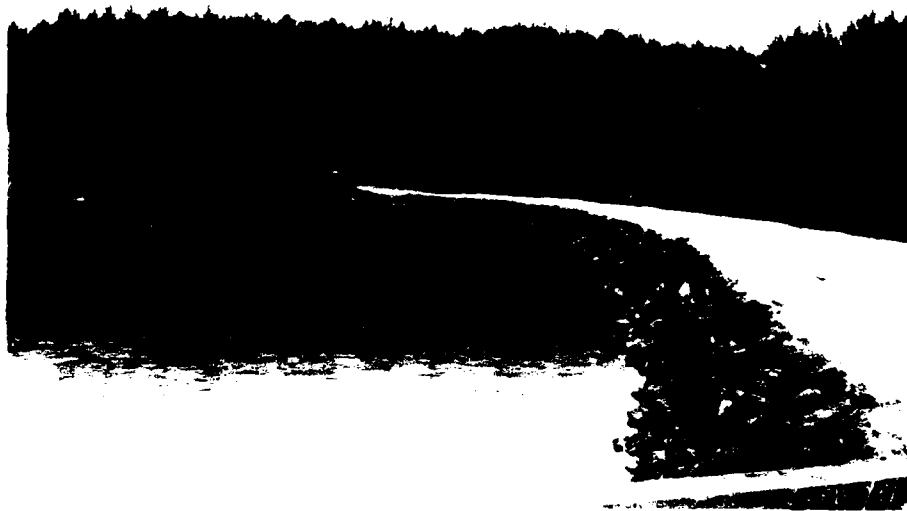
PHOTO NO. 1  
VIEW OF LEFT UPSTREAM FACE  
FROM GATE HOUSE

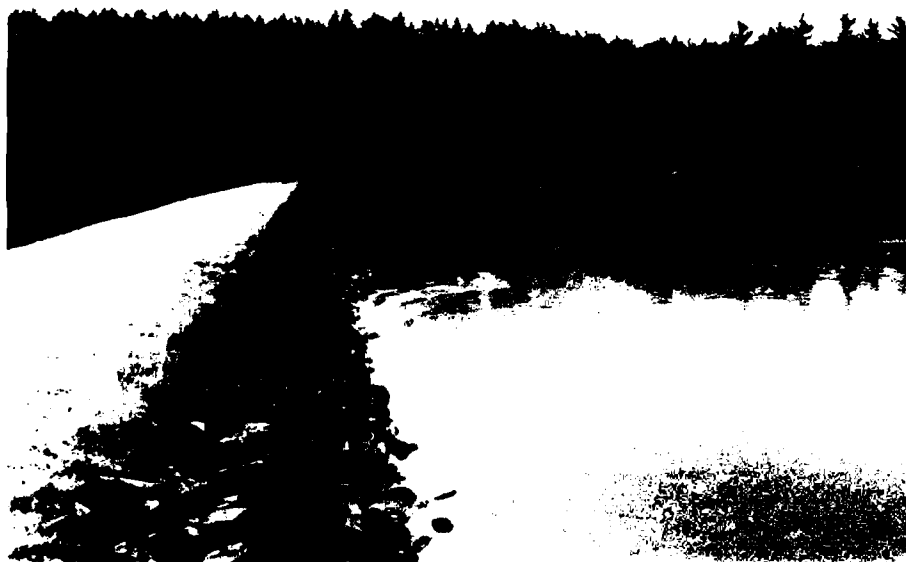
PHOTO NO. 2  
VIEW OF RIGHT UPSTREAM FACE  
FROM GATE HOUSE

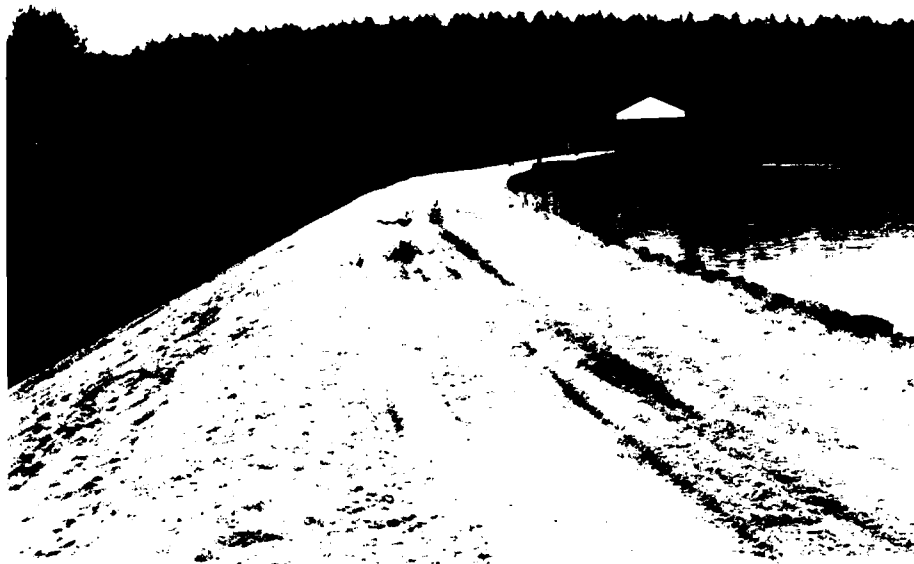
PHOTO NO. 3  
VIEW OF LEFT DOWNSTREAM FACE  
FROM LEFT END

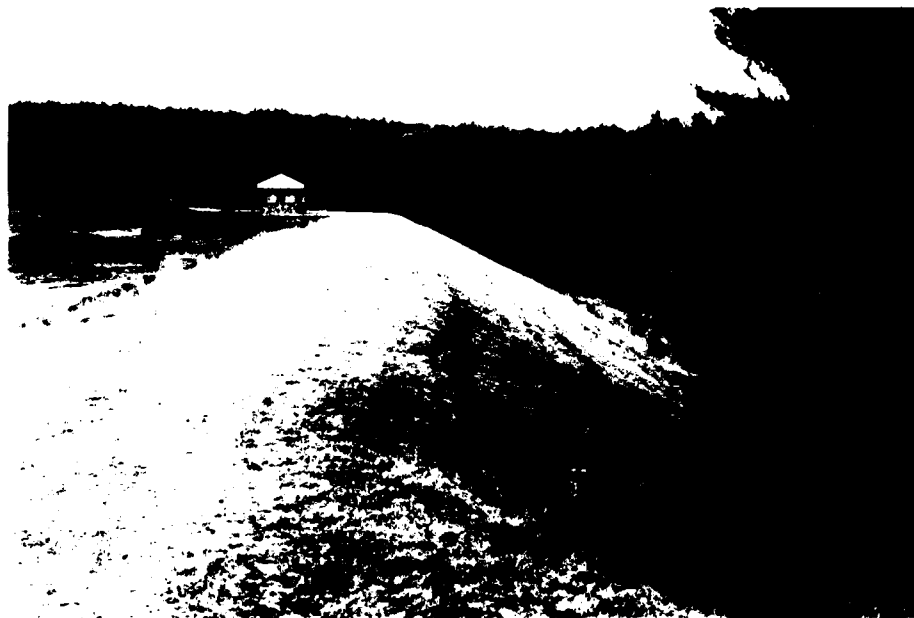
PHOTO NO. 4  
VIEW OF RIGHT DOWNSTREAM FACE  
FROM RIGHT END

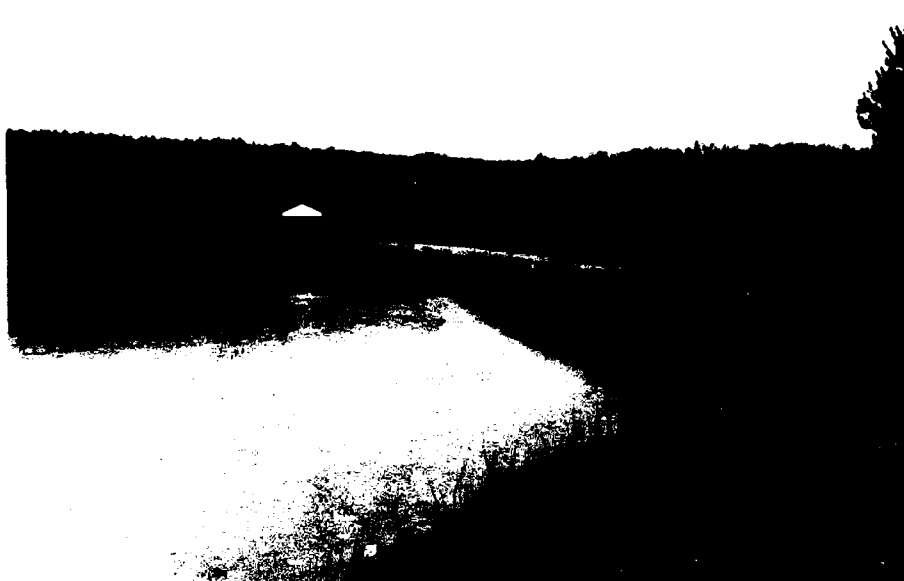
PHOTO NO. 5  
VIEW OF UPSTREAM FACE  
FROM RIGHT END

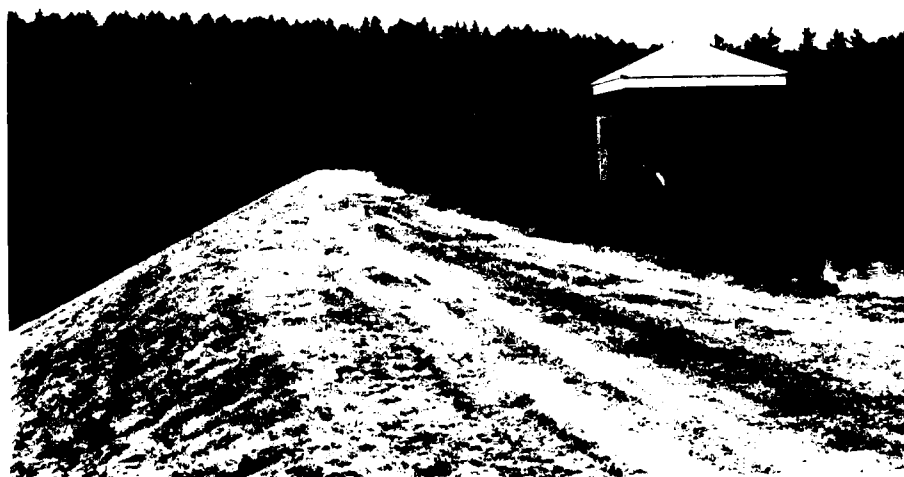
PHOTO NO. 6  
VIEW OF GATE HOUSE  
FROM LEFT SIDE

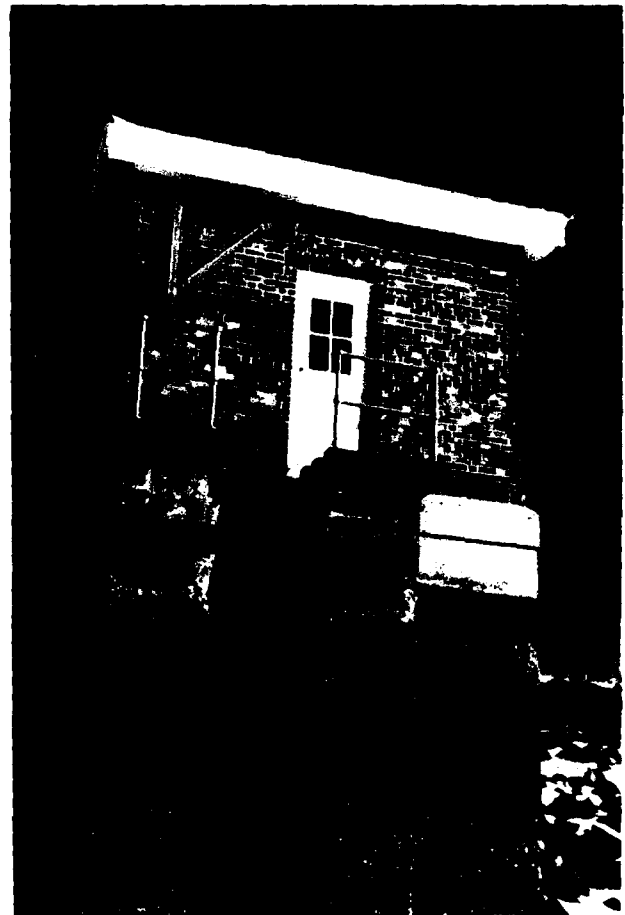
gates was fully opened and the 20-inch raw water outlet gate was open for discharge to the water supply system. Steel trash screens are located at the intake end of the structure and are in good condition. The hoisting arm and bracket for removal of the steel trash screens is well maintained.

PHOTO NO. 8  
VIEW OF UPSTREAM SIDE OF GATE  
HOUSE - NOTE BAR SCREEN FOR RAW  
WATER INTAKE LINES

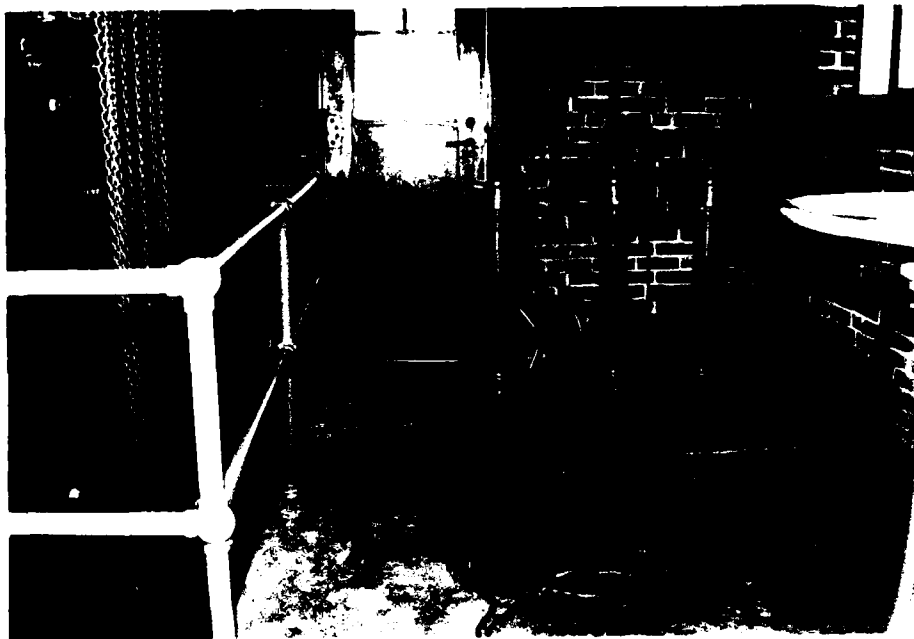
With the exception of minor brick spalling, the walls of this structure are in good condition. With the exception of minor surface erosion, the concrete foundation of this structure is in good condition without any evidence of spalls, cracks or efflorescence (see Photo No. 8). The wood framed roof is in good condition. Five wheel operated bench stands housed within the structure are in good operating condition (see Photo No. 9). At the time of the inspection, one of the 16-inch raw water inlet

PHOTO NO. 9  
VIEW OF OPERATORS INSIDE GATE HOUSE -  
NOTE CHAINFALL FOR LIFTING SCREENS AND ACCESS OPENING TO WELL
